Journal of Power Sources

Insights on the degradation mechanism of 7 Ah sodium ion batteries at different aging modes

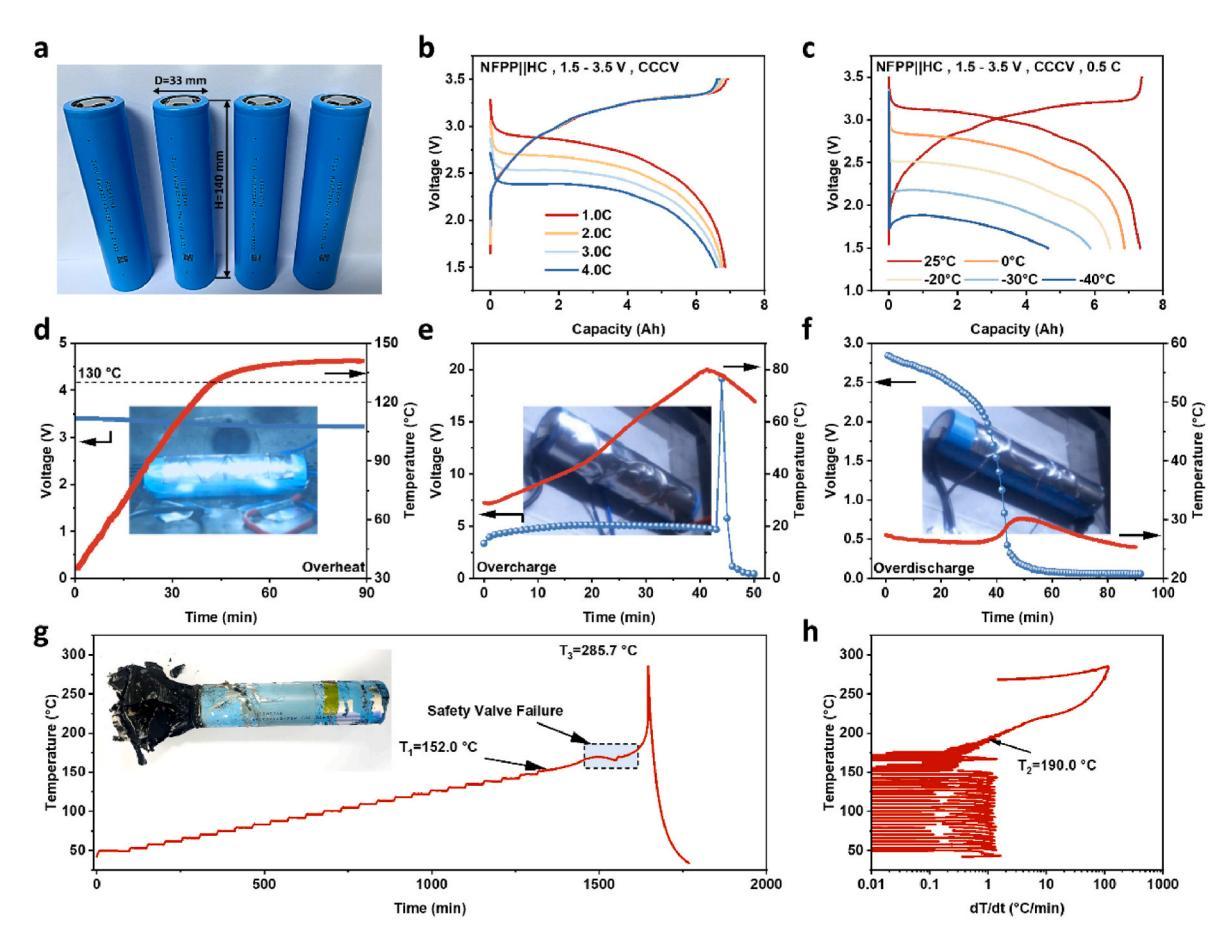
Fig. 1. Electrochemical and safety performance of SIBs. (a) Optical image of SIBs. (b) Discharge capacity at different discharge rates (the charging rate is 0.5 C). (c) The capacity of SIBs at different temperatures (low temperature). The voltage and temperature evolutions in the process of (d) over-heating test, (e) overcharge test, (f) over-discharge test (inset is the image of SIBs after safety tests). (g, h) The heat-wait-search curves of fully charged 7.3 Ah SIBs (inset is the image of SIBs after thermal runaway).

The capacity of the NFPP||HC cylindrical battery (33140, diameter = 33 mm, height = 140 mm) is 7.3 Ah, and the mass and volume energy density are 89.69 Wh/kg and 181.33 Wh/L, respectively. The batteries have excellent consistency and moderate energy density (Fig. 1(a), Figure S1, Table S2). The SIBs exhibit great potential in rate discharge, with no significant capacity and voltage reduction observed as the rate increases from 1.0 C to 4.0 C (Fig. 1(b), Figure S2). Meanwhile, SIBs also demonstrate excellent rate performance, the charge-discharge capacity at 4 C can reach 6.10 Ah (Fig. S3). Moreover, the SIBs exhibit excellent low-temperature discharge performance, with capacity retention rates of 95.02 %, 89.35 %, 81.89 %, and 64.18 % at temperatures of 0 °C, -20 °C, -30 °C, and -40 °C (Compared with the capacity at 25 °C). After low-temperature discharge and then room temperature discharge

again, the capacity can be restored to 99.72 % of the initial capacity (Fig. 1(c), Figure S4, Table S3). Subsequently, the full-charged fresh SIBs underwent safety testing that met international standards. In the tests of overheating, overcharging and over-discharging, the SIBs did not ignite or explode (Fig. 1(d-f)), which exhibited excellent safety. During the SIBs overcharge test, the highest temperature of the battery only reached 79.9 °C, and the battery did not experience thermal runaway even after internal-short circuit. In the overheat and over-discharging tests, there was no significant temperature rise observed in the SIBs. Especially, this SIBs can still be charged and discharged normally after overheat and over-discharge tests (Figure S5 (a, b)). In more stringently adiabatic environment safety test, SIBs experienced thermal runaway (Fig. 1(g and h)), with self-generated heat temperature (T_1) , thermal runaway trigger temperature (T₂, define as dT dt⁻¹ = 1 °C min⁻¹), and maximum thermal runaway temperature (T₃) of 152.0 °C, 190.0 °C, and 285.7 °C, respectively. Compared to LIBs, the safety has been significantly improved [26-28]. And before the thermal runaway occurs, the safety value opens in advance, releasing some combustible gases and electrolytes, which effectively reduces the severity of the thermal runaway. In summary, all of these indicate that the cylindrical SIBs with NFPP and HC as cathode and anode exhibit excellent electrochemical performance and safety, which is basically in line with practical applications. Thereafter, this battery will be used for research on capacity degradation mechanisms.

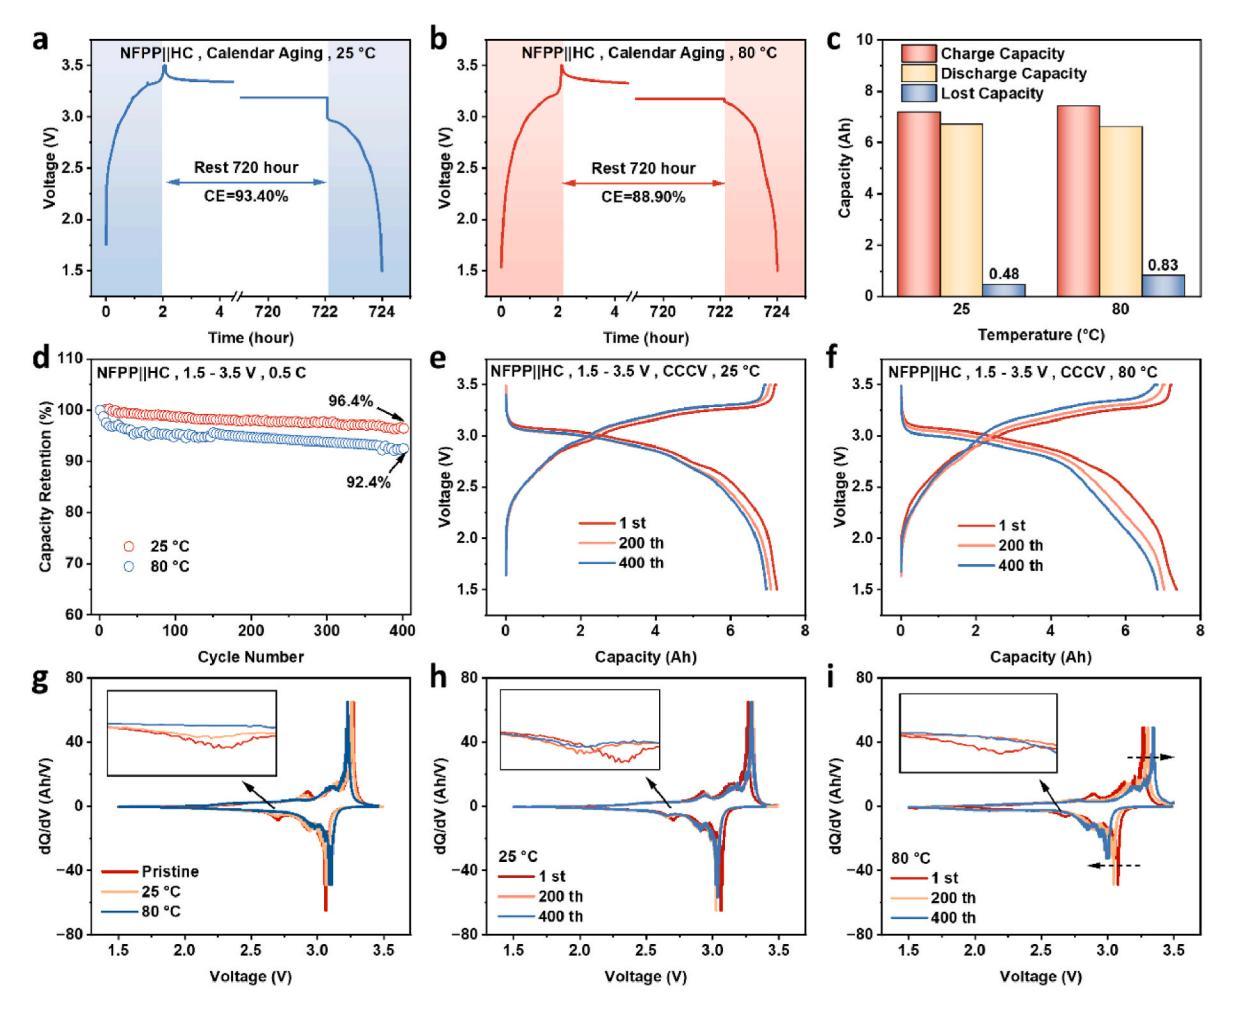
Fig. 2. Electrochemical performance during SIBs aging process. (a, b) Voltage-time curves of calendar aging at different temperatures. (c) Capacity loss of SIBs calendar aging at different temperatures. (d–f) Cycle performance of SIBs at different temperatures. (g) The incremental capacity analysis of SIBs under calendar aging at 25 °C and 80 °C. (h, i) The incremental capacity analysis of SIBs under cyclic aging at 25 °C and 80 °C. (h, ii) The incremental capacity analysis of SIBs under cyclic aging at 25 °C and 80 °C.

under extreme conditions. In this study, SIBs were used to investigate the capacity degradation mechanism in high temperature and room temperature scenarios. Herein, SIBs were used for full-charge calendar aging and cycle at 25 °C and 80 °C, respectively, and non-destructive and post-mortem characterization was combined to investigate. During the full-charge calendar aging process, the SIBs at 80 °C showed more significant voltage drop and capacity decay, with a coulombic efficiency (CE) of only 88.90 %, while the CE of aged SIBs at 25 $^\circ C$ was 93.40 % (Fig. 2(a and b)). And the capacity losses were 0.48 Ah and 0.82 Ah, respectively (Fig. 2(c)). This indicates that capacity decay also occurs during the aging process of the fully charged calendar, especially in high-temperature environments. During the cycle process, the capacity retention rate of SIBs is 96.43 % and 92.43 % after 400 cycles at temperatures of 25 °C and 80 °C, respectively (Figure S6, Fig. 2(d-f)). The reasons for the capacity degradation that occurred during these processes are further investigated.

Non-destructive characterization methods are crucial for providing fundamental insights into degradation mechanisms without destroying battery structures. Increment capacity analysis (ICA), as a non-destructive analysis method, is widely used in the analysis of battery aging mechanisms [29,30]. Its most important advantage is to transform the redox reaction of the battery into an easily recognizable capacity increment peak [31]. For NFPP cathode, Na⁺ occupies four different crystal positions in the crystal structure, with different coordination numbers, namely Na3 (five coordination), Na1 (six coordination), Na4 (six coordination), and Na2 (seven coordination) sites [32]. Three

sodium sites can be reversibly extracted or inserted into the crystal, while Na2 is electrochemically inert. The sodium extraction sequence is as follows: first, Na3 and Na1 are extracted, and then Na4 is extracted. The insertion order is reversed [33]. The multiple oxidation/reduction peaks (observed in Fig. S7) indicate the insertion/extraction of sodium ions into different sites within the structure. During the calendar aging process, the oxidation-reduction peak below 3.0 V gradually weakens with the increase of temperature, corresponding to the insertion and extraction reaction sites of Na3 (five coordinated) (Fig. 2 (g)). During the 25 °C cycle process, this oxidation-reduction peak also weakens with the increase of the number of cycles (Fig. 2(h)). More evident, the peak disappears directly after cycling at 80 °C (Fig. 2(i)). In addition, the polarization of the battery significantly increases during the high-temperature cycle process. This phenomenon may be due to the degradation of the cathode structure, which leads to the decrease in the activity of the Na3 site, or the loss of active sodium causing sodium ions to be unable to fully occupy the sites. For this speculation, further verification will be conducted through post-mortem analysis.

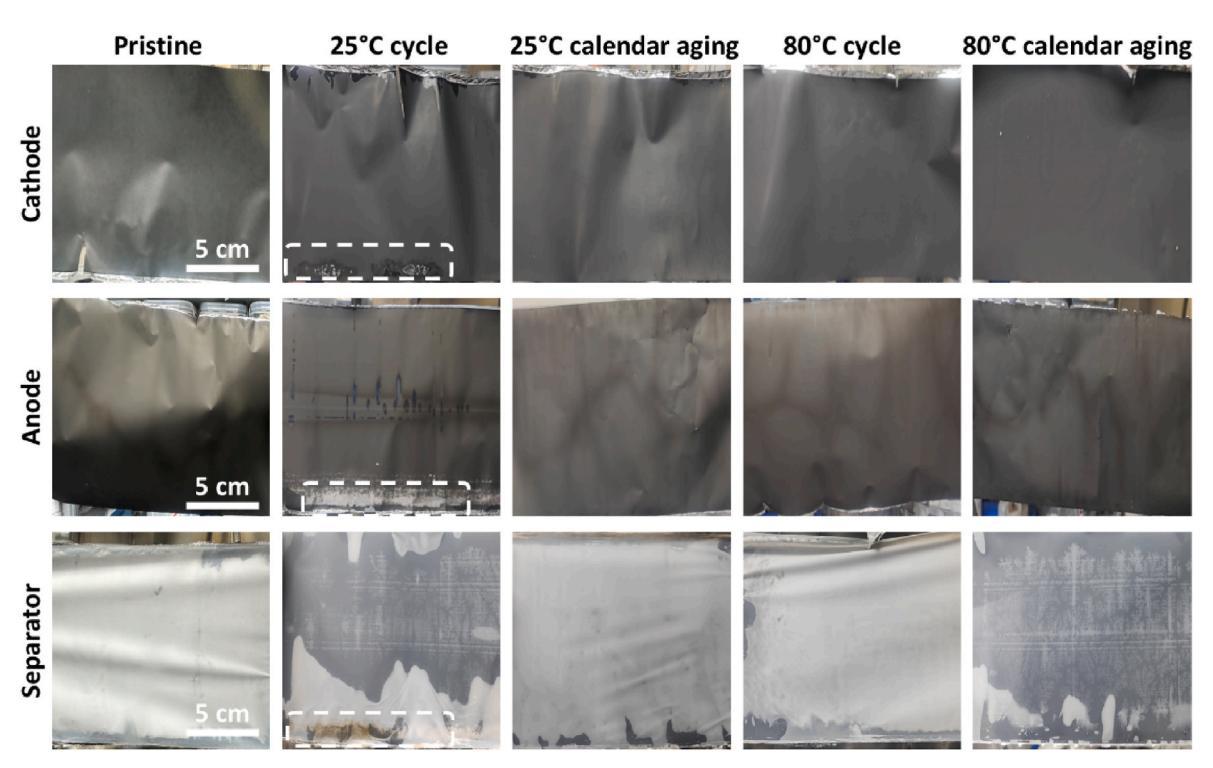
Fig. 3. The image of separator, cathode and anode disassembled from the SIBs with different aging modes (All batteries were disassembled at discharged state).

optical images of the separator, cathode, and anode after battery disassembly are shown in Fig. 3. Except for SIBs that have undergone room temperature cycle, there are little differences in the appearance of the cathode, anode and separator between the pristine and degraded battery. Obviously, the anode of SIBs undergoing room-temperature

cycle has severe sodium plating, and the by-products of the reaction between sodium metal and electrolyte adhere to the separator and cathode. This also indicates that the N/P ratio (capacity ratio of anode to cathode) design of battery is not reasonable enough, the conductivity of electrolyte and the solid-phase diffusion of sodium ions are relatively

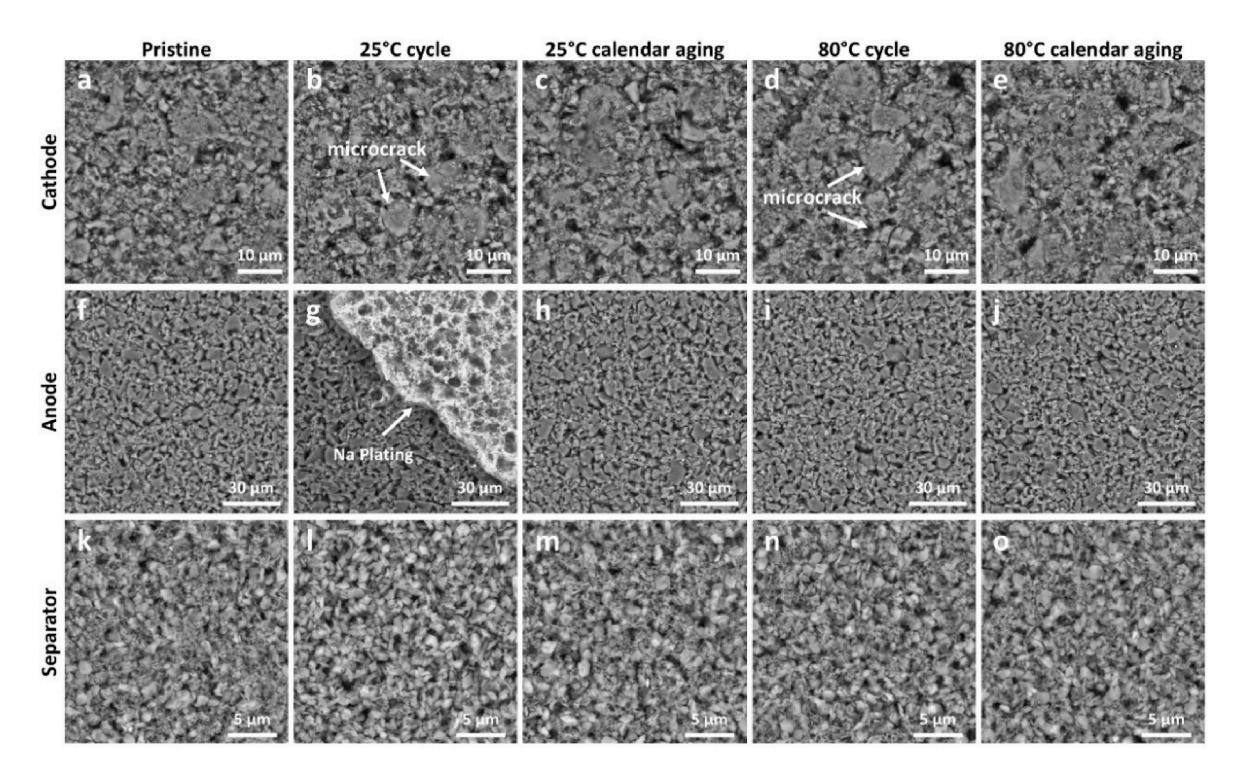
Fig. 4. SEM images of cathodes under different aging modes: (a) Pristine; (b) Cycle at 25 °C; (c) Calendar aging at 25 °C; (d) Cycle at 80 °C; (e) Calendar aging at 80 °C. SEM images of anodes under different aging modes: (f) Pristine; (g) Cycle at 25 °C; (h) Calendar aging at 25 °C; (i) Cycle at 80 °C; (j) Calendar aging at 80 °C. SEM images of separator under different aging modes: (k) Pristine; (l) Cycle at 25 °C; (m) Calendar aging at 25 °C; (n) Cycle at 80 °C; (o) Calendar aging at 80 °C.

low. Therefore, the design of electrodes is crucial for the construction of safe SIBs [34,35]. Further, SEM images of pristine and degraded cathode were used to analyze the degradation of NFPP particles and surfaces (Fig. 4(a-e)). The cathodes after calendar aging at 25 °C and 80 °C exhibited the same morphology as that of the fresh cathode with the particles remaining intact. However, particle microcrack is observed in the cathodes cycle at 25 °C and 80 °C, which means that there is a manifestation of slight degradation of the active material during the cycle process (Fig. S8). Particle microcrack can lead to poor intergranular connections and create new sites for surface corrosion and side reactions, thereby accelerating battery capacity degradation [36]. They did not occur during the calendar aging process, indicating that the particle microcracks were structural degradation caused by electrochemical reactions, rather than erosion of the electrolyte at high temperatures. The sodium plating and structural degradation behavior of HC under multiple conditions were observed by SEM (Fig. 4(f-j)). After room-temperature cycle, there is a large-area moss-like sodium plating on HC anode and by-products on separator, while those under other aging modes do not exhibit sodium plating or other obvious phenomena. We analyzed the deposits on the surface of the HC by SEM-EDS (Fig. S9). EDS testing showed that the regions on the HC surface where deposits exist are rich in Na and O elements, with relatively less C. It can be initially speculated that the substance is Na2O (It is caused by the reaction of sodium plating with oxygen in the air during the SEM sample injection process). Combined with further ssNMR testing, it was proven that the deposits on the HC surface are metallic sodium (Fig. S10). In summary, we have confirmed that the deposits on the surface of HC are

sodium plating. SEM is used to further characterize the microstructure of by-products. It can be observed that the ceramic particles of the ceramic separator have been detached, and at the same time, some ceramic particles adhere to the cathode electrode. The position of by-products is very consistent with that of sodium plating, indicating that the by-products are generated by the reaction between active sodium and electrolyte (Figs. S11(a and b)). The stripping of ceramic particles undoubtedly reduces the dimensional stability of the separator and deteriorates the safety of the battery. No significant changes were observed in most areas of the separator under any aging mode (Fig. 4(k-0)).

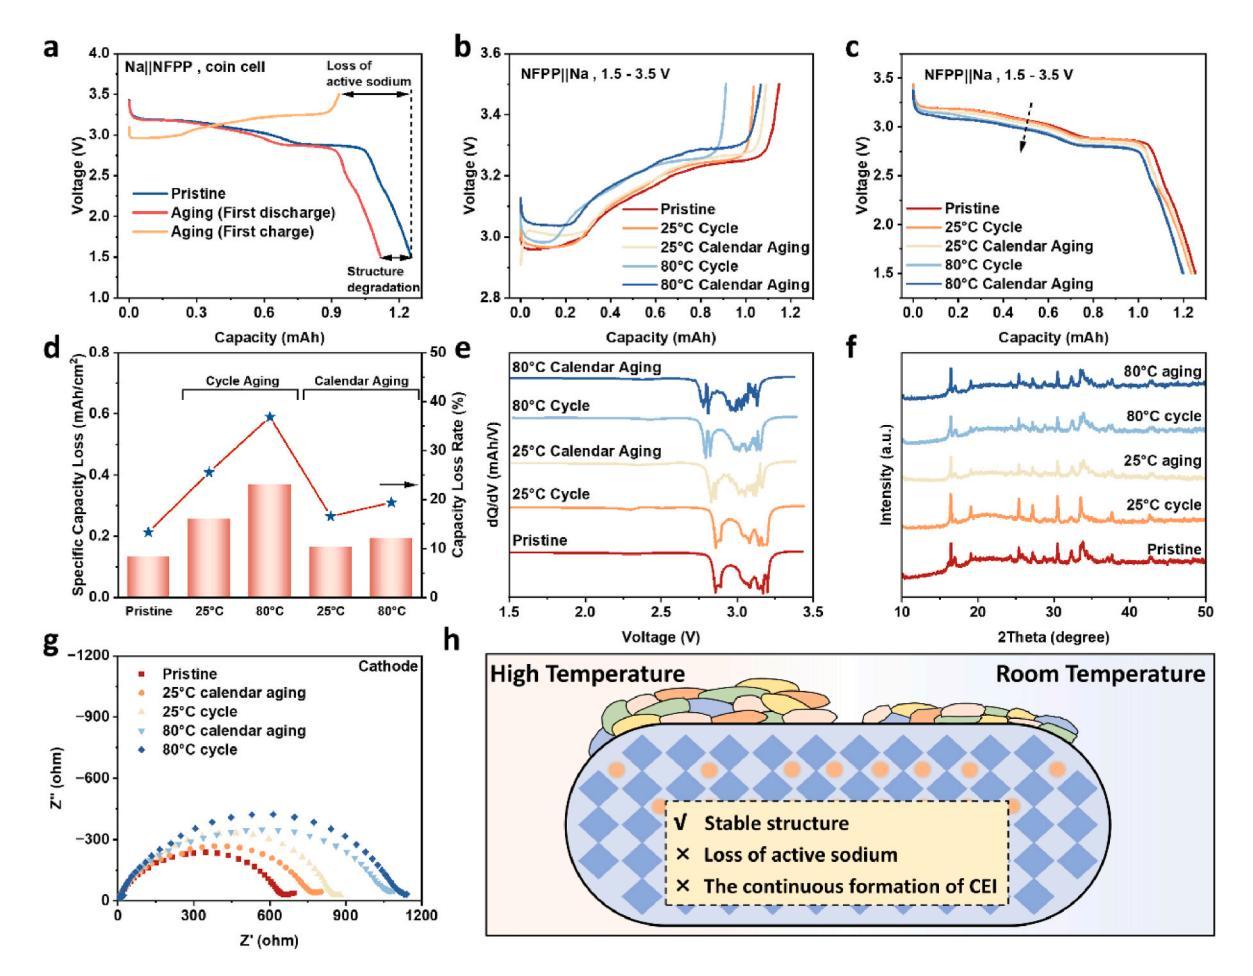
Fig. 5. Capacity degradation mechanism analysis of cathode materials. (a) Capacity loss of various parts of cathode materials. (b, c) Charging and discharge curve of NFPP||Na coin cells (The NFPP electrodes were obtained from disassembled batteries). (d) Specific capacity loss and capacity loss rate of SIBs. (e) The incremental capacity analysis of cion cell during discharge process. (f) XRD patterns of cathode materials undercoin different aging modes. (g) EIS curve of NFPP||Na coin cells. (h) Schematic diagram of cathode failure.

In order to decompose the contribution of the cathode and anode electrodes to the capacity degradation of the battery in terms of structural degradation, polarization, and other aspects, the disassembled cathode and anode were separately reassembled with sodium metal to form a coin type half-cell. The NFPP||Na half-cells were charged to 3.5 V with a current of 1.1 mA, to calibrate the residual capacity of the cathode materials (Fig. 5(a)). Then, through discharging to 1.5 V, sodium ions insert back into the cathode material to eliminate capacity degradation caused by loss of active sodium (Fig. 5(b)). After testing, it can be preliminarily found that during the process of sodium ions extraction, the cathode materials after high-temperature and roomtemperature cycle only exhibit a capacity of 0.91 mAh and 1.04 mAh (the capacity of pristine cathode is 1.15 mAh), while the capacity of the cathode materials after high-temperature and room-temperature calendar aging is 1.09 mAh and 1.07 mAh, respectively. This explain that the loss of active sodium caused by interface side reactions in hightemperature cycling is more severe than the sodium plating during

room temperature cycling. When sodium ions embed back into cathode, the active sites of NFPP can be almost completely inserted by sodium ions, and there is no significant difference between the aged cathode material and the pristine sample (Fig. 5(c)). The specific capacity loss of active sodium after cycle (25 °C and 80 °C) is slightly higher than calendar aging (Fig. 5(c and d)). It is worth noting that the loss of active sodium in the pristine SIBs after formation and capacity calibration also reached 13.3 %, indicating that the insufficient initial coulombic efficiency (ICE) of the HC resulted in excessive consumption of active sodium in the battery, thus seriously reducing the capacity utilization of SIBs.

At the same time, we conducted ICA on the discharge curve of the NFPP||Na cells, and found that the reduction peak did not show significant changes compared to the fresh cathode (Fig. 5(e)). Especially, the peak below 3.0 V reappeared in the high-temperature aged cathode material, indicating that the Na3 sites still have electrochemical activity. In the SIBs, the loss of active sodium is the main reason for the disappearance of the Na3 sites peak below 3.0 V, and the structure of NFPP does not significantly deteriorate during the aging process. Significantly, the polarization of the aged cathode materials increases during the charging and discharging process (especially after high-temperature aging). The XRD patterns of cathode materials under different aging modes also indicate that the structure of the cathode materials has not deteriorated and there is no generation of impurities, which also proves the above analysis conclusion (Fig. 5(f)). In addition, the EIS of NFPP Na coin cells was used to further characterize interfacial charge transfer resistance (R_{ct}), all the degraded batteries exhibit increased impedance (Fig. 5(g), Figure S12). At the same time, the R_{ct} of the batteries after high temperature aging also significantly increases (compared to room temperature aging). Impedance data and polarization data have also confirmed each other.

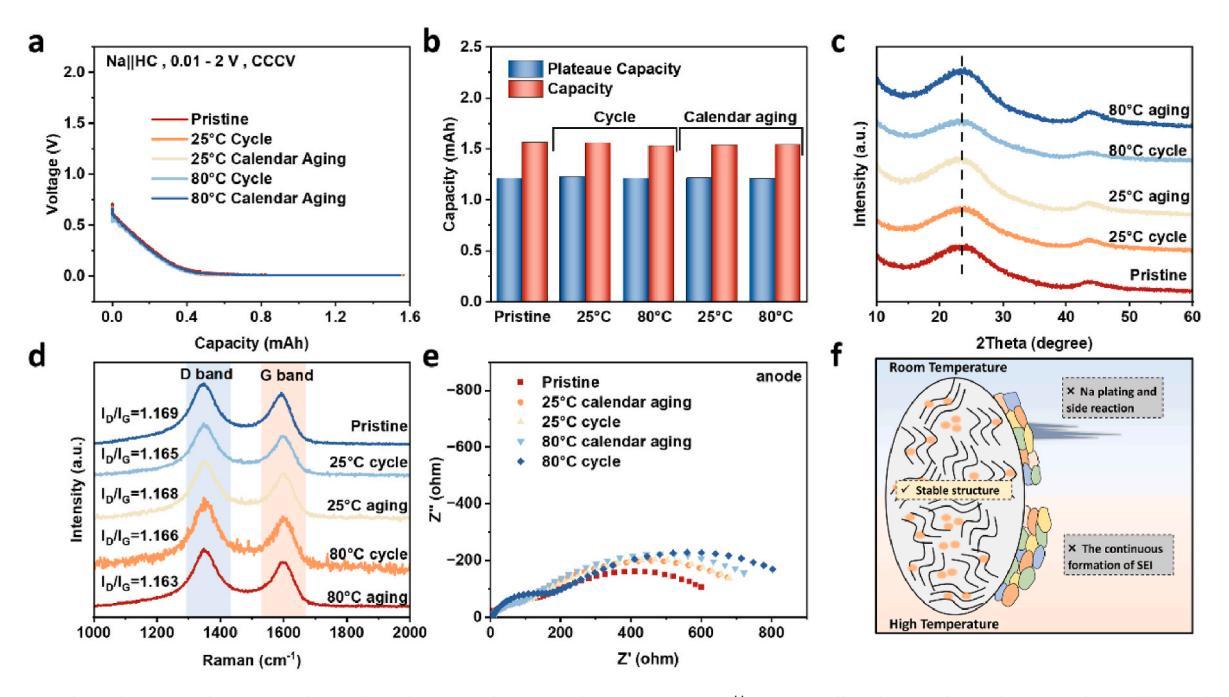
Fig. 6. Capacity degradation mechanism analysis of anode materials. (a) Discharge curve of HC||Na coin cells (The HC electrodes were obtained from disassembled batteries). (b) Capacity statistics of different coin cells. (c) XRD patterns of anode materials under different aging modes. (d) Raman spectrum of anode materials under different aging modes. (e) EIS curve of HC||Na coin cells (inset is the equivalent circuit to fit impedance spectra of the batteries.). (f) Schematic diagram of anode failure.

The HC anode is also used to reassemble coin cells for further measurement of sodium storage capacity (HC has selected areas without sodium plating). From the discharge program of constant current and constant voltage (CCCV), the discharge curves of HC before and after aging highly overlap, and there is no significant difference in the sodium storage capacity, plateau capacity, and slope capacity of aged HC compared to fresh HC (Fig. 6(a and b), Fig. S13). This means that the structure of HC (including pseudo-graphite and micropores) has not deteriorate under various aging modes [37,38]. The XRD pattern indicates that the structure parameters such as average interlayer spacing, average layer stacking distance of HC have not undergone significant changes (Fig. 6(c)). Raman spectroscopy (Fig. 1(f)) is further conducted to assess the microstructure of HC. The peak positions of the D and G peaks of HC before and after aging are around 1353 cm⁻¹ and 1594 cm^{-1} , with no significant shift observed, and the I_D/I_G ratio remains unchanged. This indicates that the edge defects and microcrystals of HC are not damaged. Overall, the structure of HC did not show significant deterioration during the aging process. From the interfacial impedance test results of HC anode, it can be found that the SEI impedance (R_{SEI}) and R_{ct} of the aged electrodes both increase significantly, and the impedance increase of the high-temperature aged electrode is more pronounced, which may be due to the side reactions at the HC interface (Fig. 6(e), Figure S14). Therefore, the structure of HC will not be destroyed during the cycling process, and the increase in interfacial impedance is the significant reason for the degradation of battery capacity, especially for batteries aging at high-temperature. During the cycling process at room temperature, the battery exhibits sodium plating, resulting in loss of active sodium and safety hazards (Fig. 6(f)).
